# Manhole Inspection Summary

Manhole # S29AA\_020MH

Insp Date: **4/22/09 11:43 AM**

**Location** Address: **500 HOFFMAN ST**

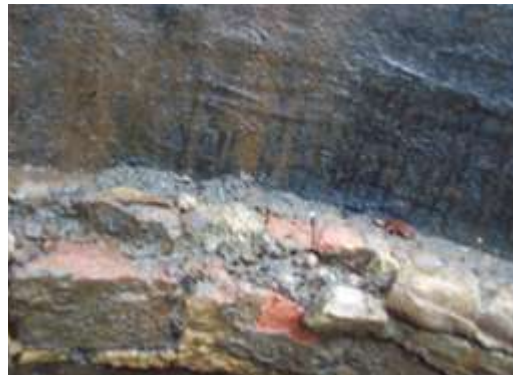
Defect 2

Condition: ☐ Sound ☒ **Cracked** ☐ Root Intrusion ☐ Loose Brick ☐ Deteriorated

CRACKED CHIMNEY

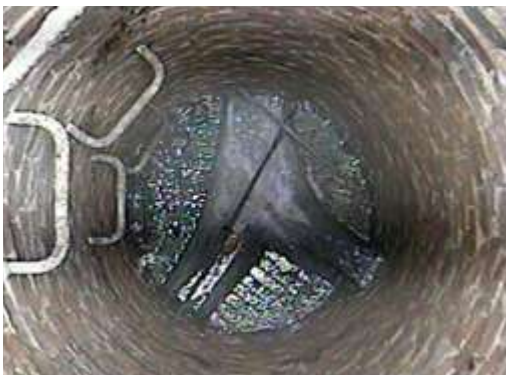
Defect 1

Count: **8** Missing: **0** ☒ **Corroded**

STEPS CORRODED

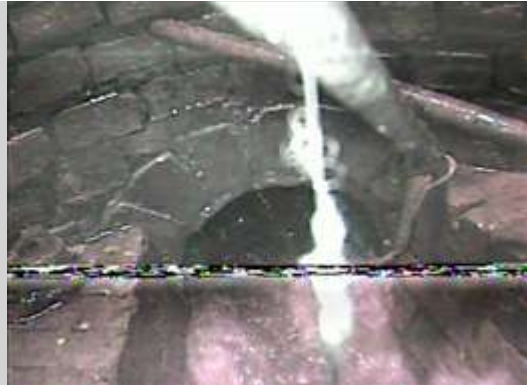
12 O'Clock Outflow

Pipe Height: **7.2** (in.) Rod and Bar  
Pipe Material: **Clay** ☐ Pipe Lined  
Invert Depth: **13.24** (ft.) Flow Characteristics: **Fast**  
Deposits: ☒ None ☐ Mud ☐ Sludge ☐ Debris ☐ Grease  
Silt Depth: (in.) Deposits Extent:  
Infiltration: **None** Pipe Seal Cond: **Sound**

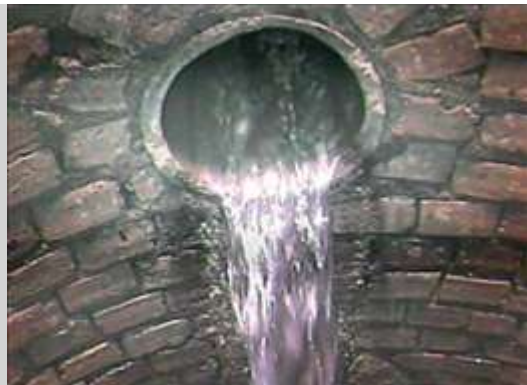
4 O'Clock Inflow

Pipe Height: **6** (in.) Rod and Bar  
Pipe Material: **Clay** ☐ Pipe Lined  
Invert Depth: **10.43** (ft.) Flow Characteristics: **Fast**  
Deposits: ☐ None ☐ Mud ☐ Sludge ☐ Debris ☒ Grease  
Silt Depth: **0** (in.) Deposits Extent: **Light**  
Infiltration: **None** Pipe Seal Cond: **Sound**

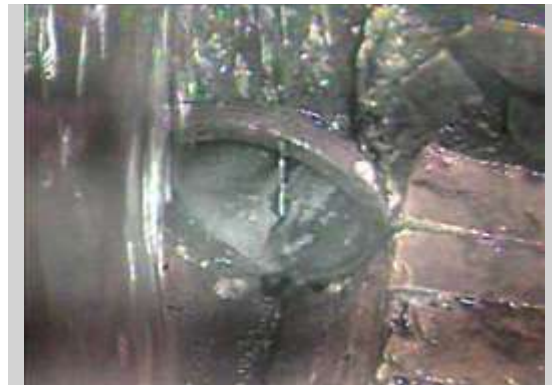
Drop In @ 4 O'Clock

Drop: **Outside Direct**  
Angled: Reading: (ft.)  
Inv Depth: **12.64** (ft.)  
Drop Condition: **Open**

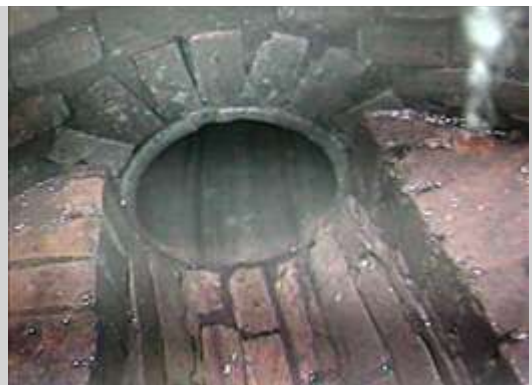
7 O'Clock Inflow

Invert Depth: **12.80** (ft.) Flow Characteristics: **Fast**

Deposits: ☒ None ☐ Mud ☐ Sludge ☐ Debris ☐ Grease

Infiltration: **None** Pipe Seal Cond: **Sound**
